Atalanta Owners' Association

*61st Annual
Bulletin*

A169 “Elle” (formerly Kerry Piper) Wooden Boom and Mast rebuild 2018 by Chris Green

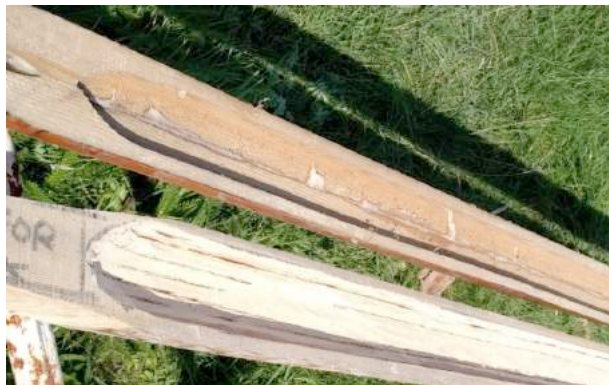
Figure 1. New section routed – taper shaped for gooseneck fitting.

Firstly, the original boom was cut in half lengthwise and new lower part cut to size. Original top and new bottom sections were aligned new timber was marked for internal routing and external shaping.

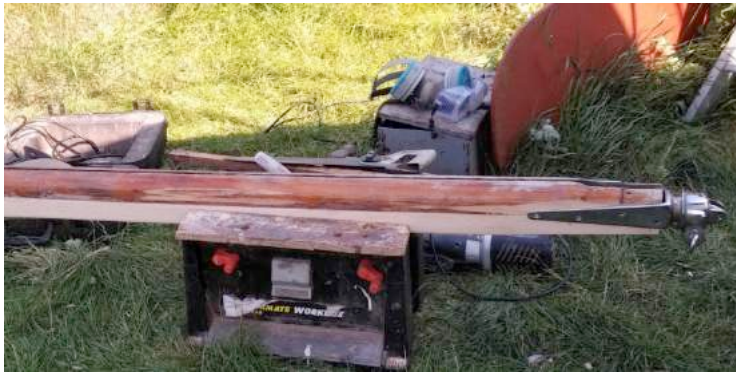
Figure 2. Old top section glued to new lower

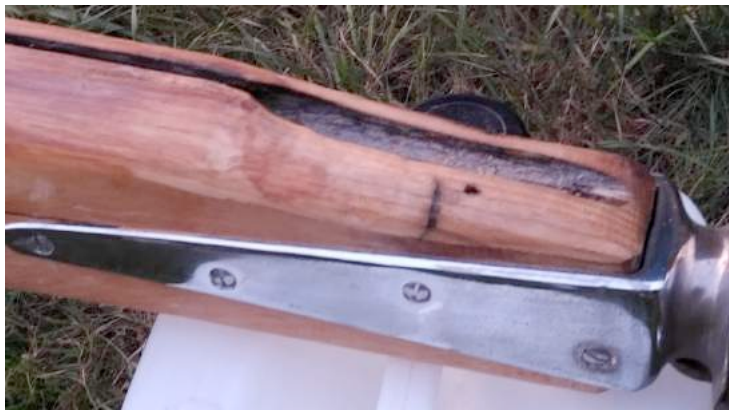
Figure 3 Gooseneck final Fitting

A customised sliding gooseneck mast fitting was made up from surplus 2mm stainless steel sheet – left over from the electric motor housing (see AOA website for installation); and a 30mm length ss bar plug-welded to take the sliding car (see mast section below for sliding gooseneck photo).

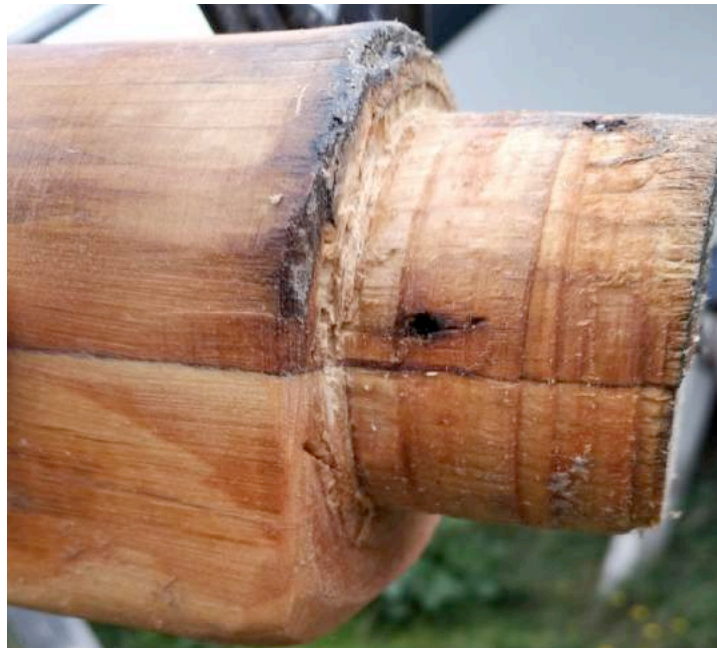
Figure 4 Boom end shaped for new mainsheet end fitting

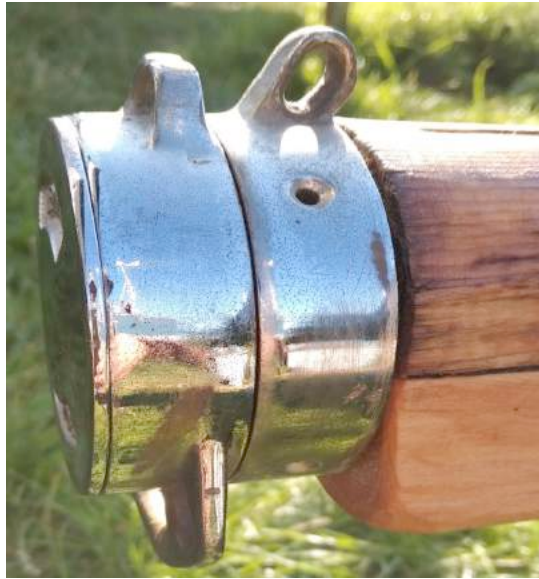
Figure 5 Boom end fitting

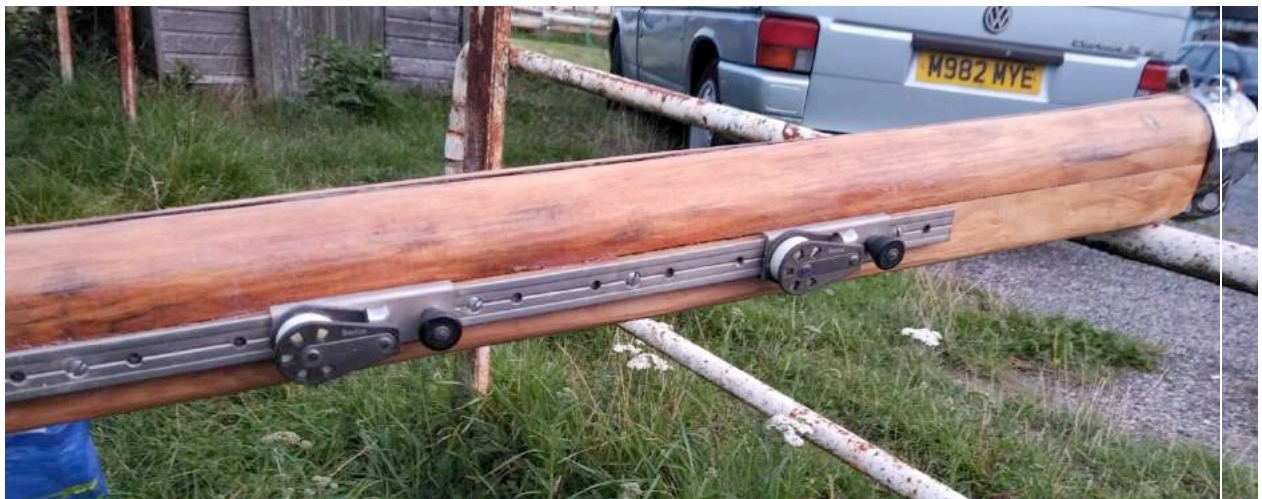
Figure 6 Boom reefing added

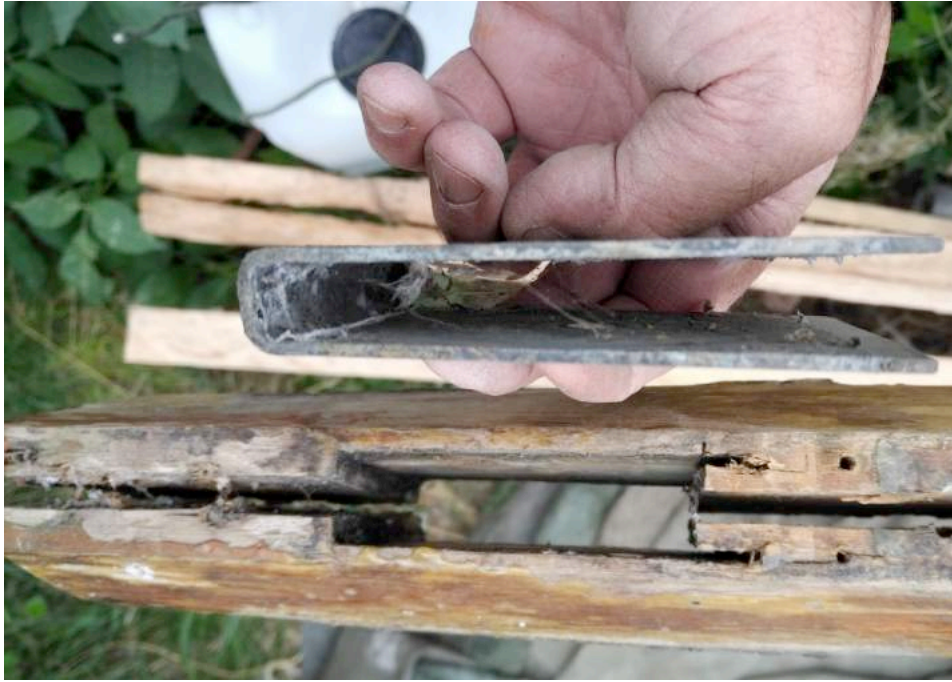
Figure 7. Main Halyard sheave fitting removed.

Another issue with the masthead sheave was that the centre bush had gone leaving the 7mm centre bolt /spindle in a 14mm sheave hole; so new bush was fabricated from drilled-out Tufnol rod. The mainsail track and bronze mast base step fitting were sandblasted prior to refit (photos) NB: Track not yet fitted at time of writing.

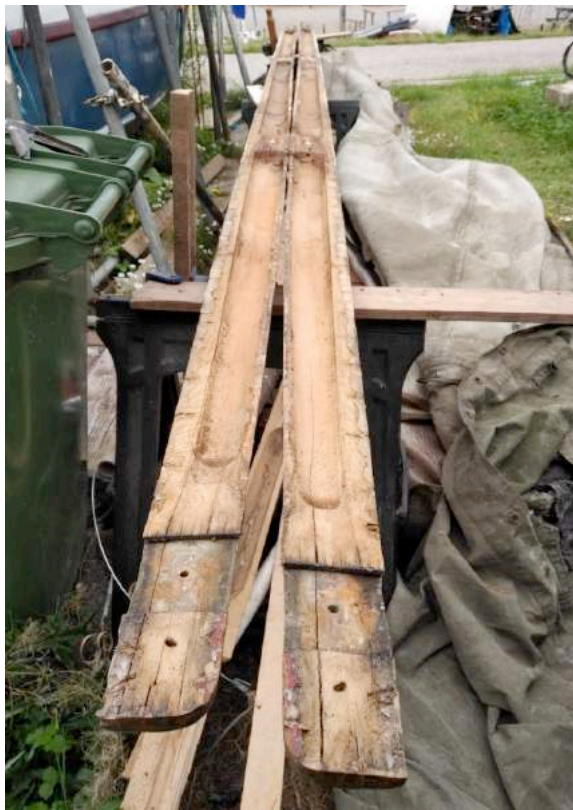
Figure 8. Mast sections separated – clean break along joins.

Much of the seam join had opened; the lower third of mainsail mast-track had been filled with a flexible Sikaflex type product. NB: where the original glue was intact it still formed a perfect bond! Most opened seam issues appeared to result from track fixings etc allowing water ingress into the join and rotting the adjacent timber. This was likely to have been happening over the 10 years of lay-up on her trailer before I acquired A 169.

The dreaded job was finally under way (from first week in September) starting with opening the glued seams along its length (see photos) and separating the two halves. The damage was not quite as terminal as first appeared and after some research I was confident all the structural repairs could be remedied with epoxy glued spruce splines (internal and external). Plenty of the Sitka spruce from the boom rebuild was available for this.

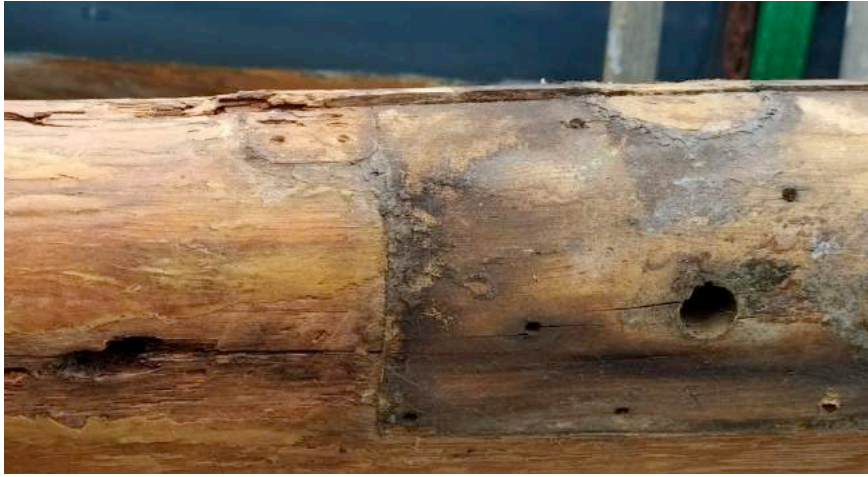
Figure 9 Diamond brace area – external view of damage

The mast was in a sorry state – fractures / rot at the diamond spreader bracket; same issues but even worse at the main spreaders; rusted galvanized through bolt at mast base - water ingress etc – see the first photo section for the gory detail.

Fractures and holes at the spreader and diamond brace fitting (photos....) had the new solid internal splines inside the mast immediately below the visible damage, but still required spline scarf repairs for a complete repair. The damaged/rotted spruce was cut out down to the new solid spline below at both areas – 40x7cm at the diamond brace (starboard) and 70x 7cm at spreaders (port). New Sitka spruce splines were cut, shaped and epoxy glued /clamped (photos).

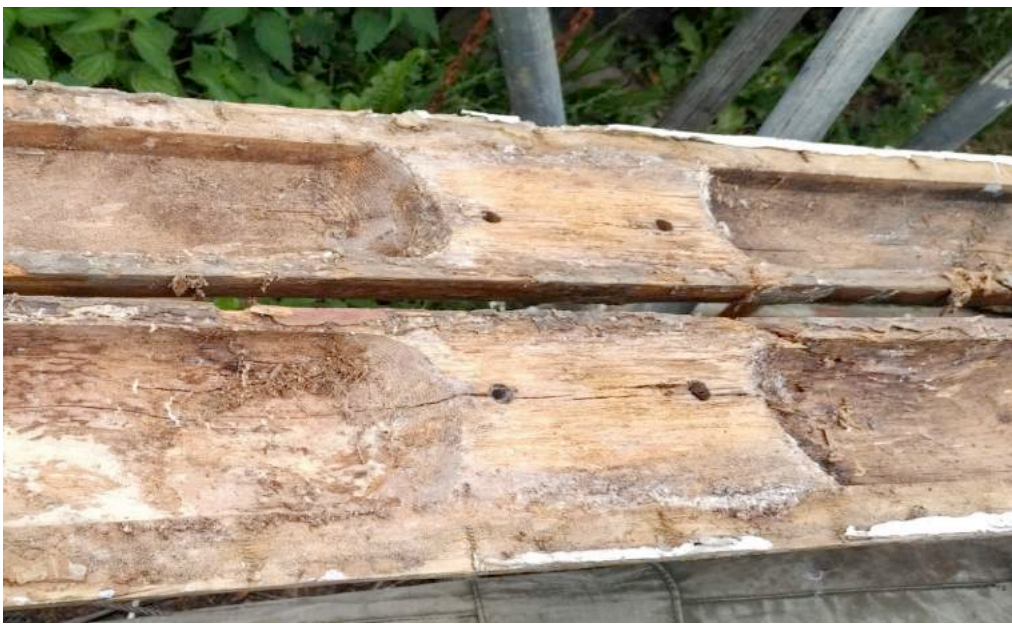
Figure 10 Diamond brace area – internal view of damage.

Second week in September the first step - separated halves laid out on trestles (inside face-up) - was to rout 50mm slots through the solid 250mm mast joins (in each half) at crosstrees and diamond brace (4 total); 90cm formed splines were then glued into each slot either half of mast. Specifically, the splines were set into the forward mast edge; each spline overlapped the solid joins (shaped into the front edge radii). The spreader and diamond brace through-mast fastenings will pull both splines together when mast is reassembled (see photo). So, the effect will be to reinforce and extend the solid join to 90cm at the two areas of mast stress.

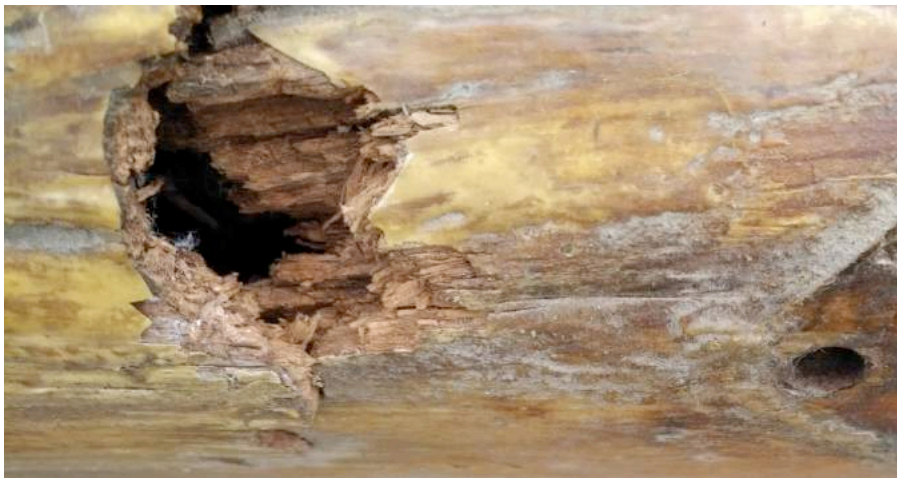
Figure 11 Spreaders area – external view of damage.

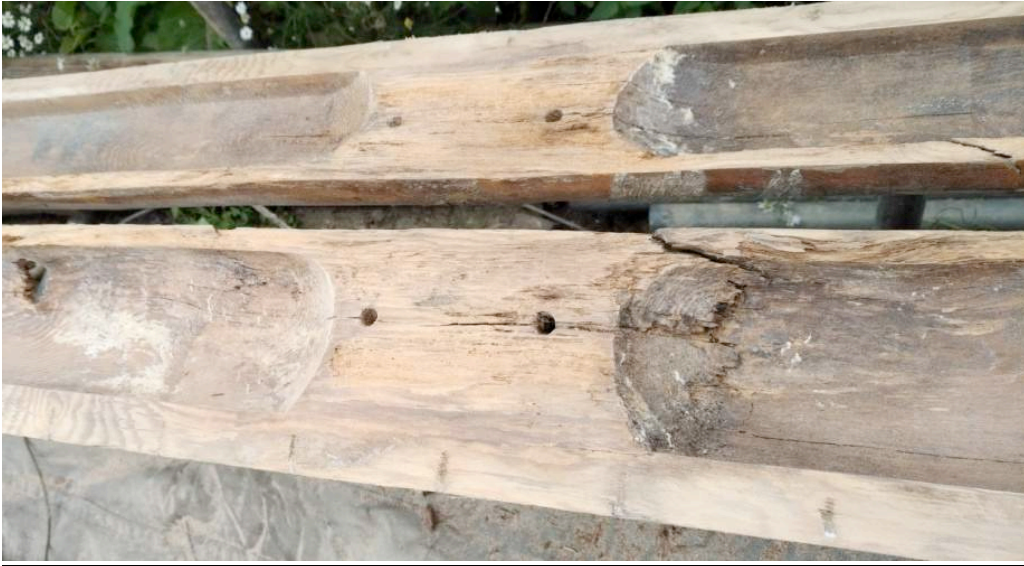
Figure 12 Spreaders area – internal view of damage.

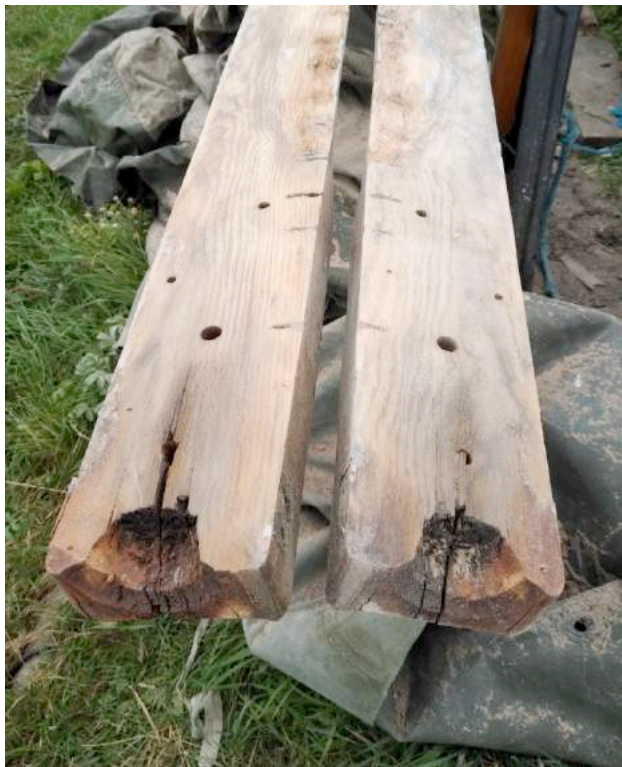
Figure 13. Mast base section – internal view.

Mast base had the remains of the oxidized galvanised (halyard winch) bolt removed – see photos for the damage caused to this area, the timber was mostly sound however and was given an initial saturation coat of epoxy into the opened grain.

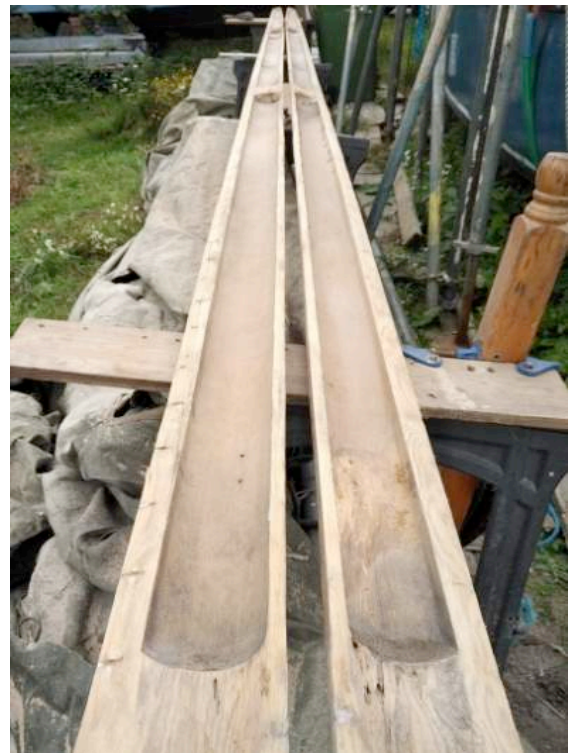
Figure 14 Mast sections after prep clean for repairs.

Cleaned internal sections were given a saturation coat of epoxy at the short intermediate solid joins (i.e. where the mast is not hollow); the original timber although still mostly sound had some grain separation (photos). Saturation coats were also applied to the inside of the fracture at the crosstree spreaders. This section was splinted with a couple of tightened lanyards to assist in retaining the shape prior to the spline repairs.

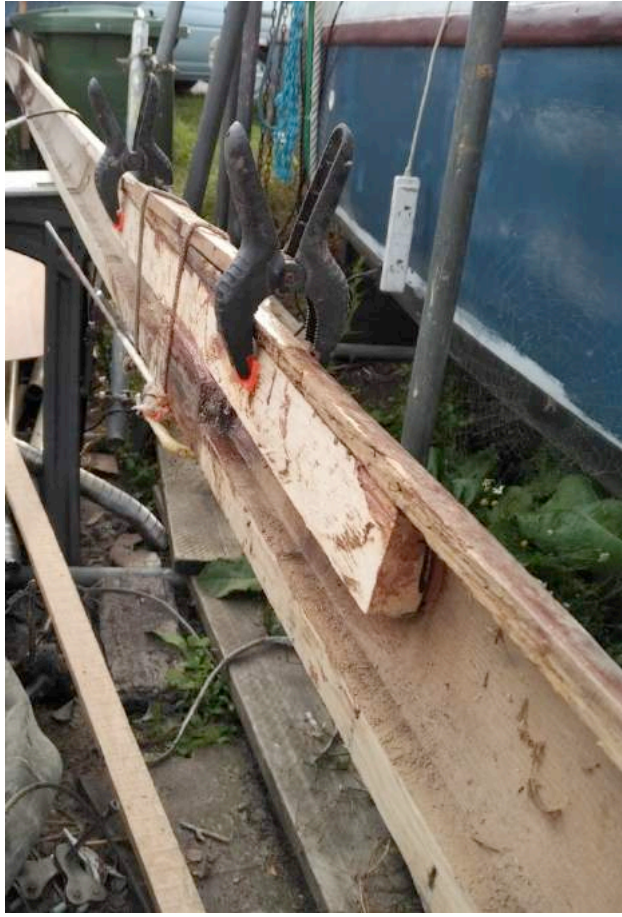
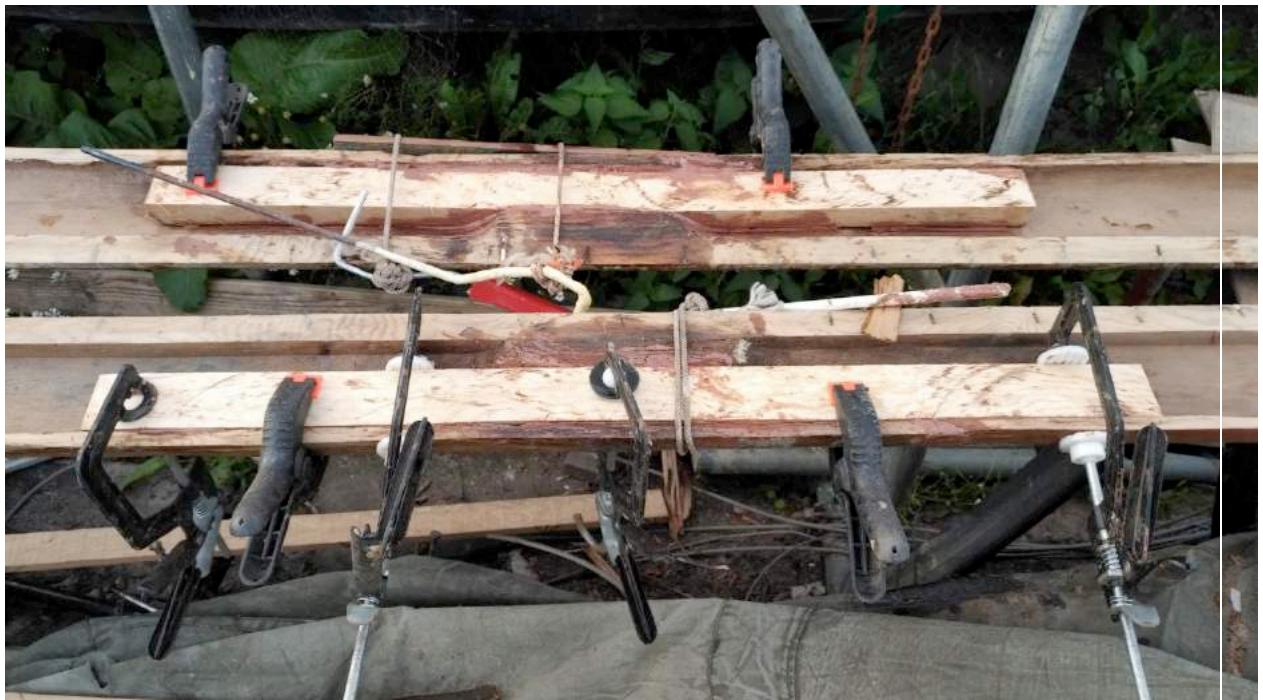
Figure 15. Spruce splines epoxy glued inside crossbeams.

Figure 16. Another view of spruce splines epoxy glued inside crossbeams.

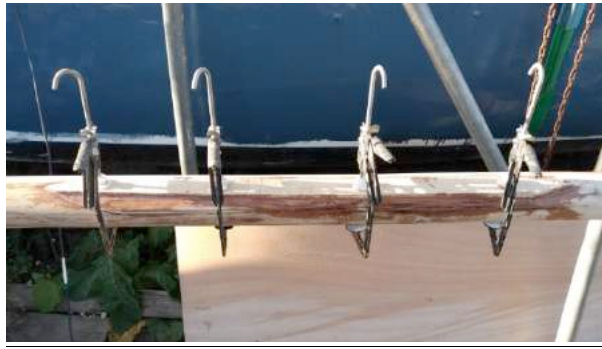
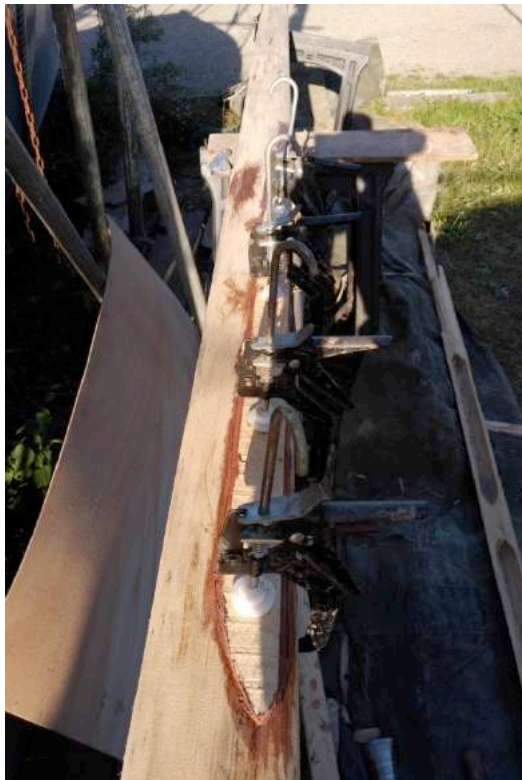
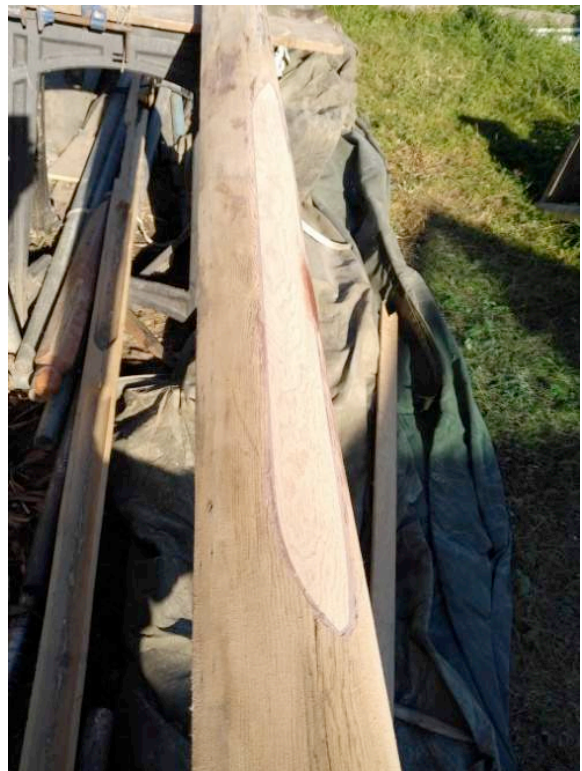
Figure 17. Spruce scarf section epoxy glued – spreaders.

Figure 18. Another view of Spruce scarf section epoxy glued.

Figure 19. Spruce scarf section at spreaders.

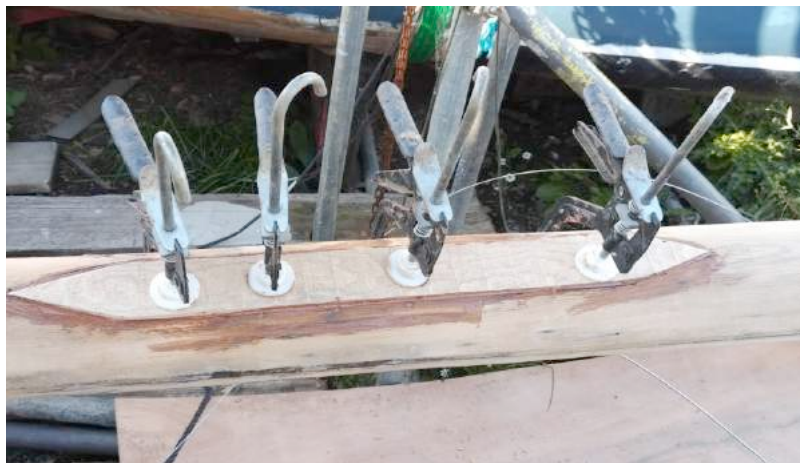
Figure 20. Scarfed graving piece.

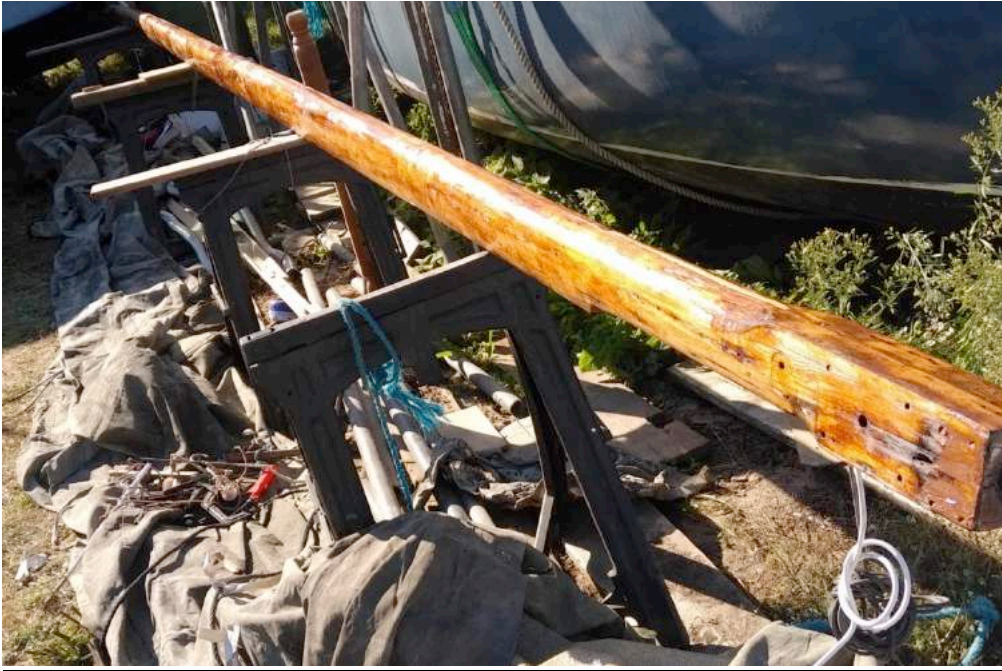
Figure 22. Mast re-varnished.

After removing clamps, new repairs were rubbed down and the whole mast given a coat of clear epoxy (UV resistant); further coats of UV varnish will be added over the next few months before going afloat next year.

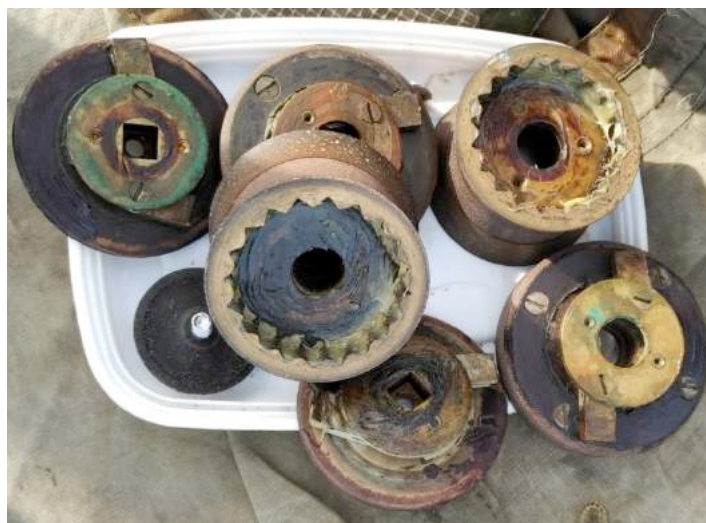
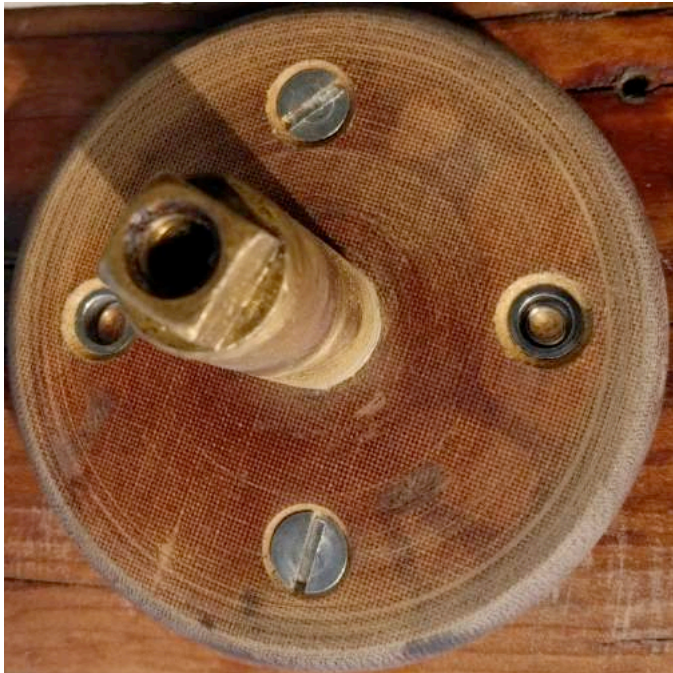
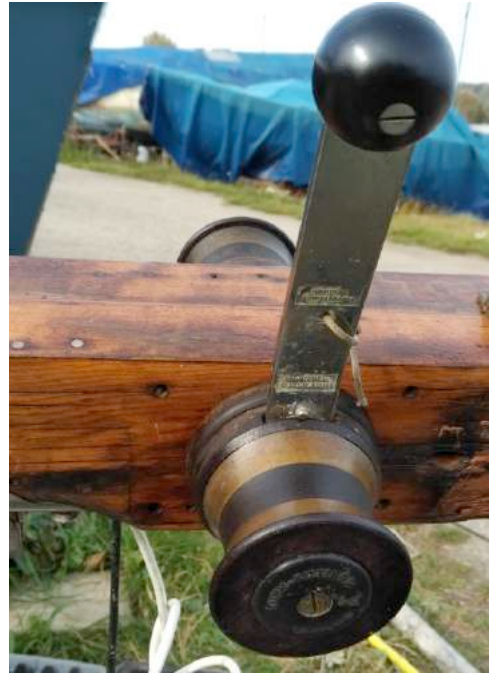
Figure 31 Tufnol winch parts.

Figure 32. Tufnol winch base

Figure 33. Winch fitting complete.

Original wire halyard winches were replaced with Tufnol two-speed rope type (photos). Annoyingly, the new winches required four through-mast bolts instead of the single through bolt fixing of the original. Four single fixings for both winches was achieved with the use of countersunk rivet nuts mated to 4 x 120mm countersunk machine bolts (hole alignment - bit of a faff). This type of Tufnol winch is attached by the base and the upper part is fastened onto the spindle (in the base). So, the two base plates are fastened together through the mast with the four nuts/bolts.

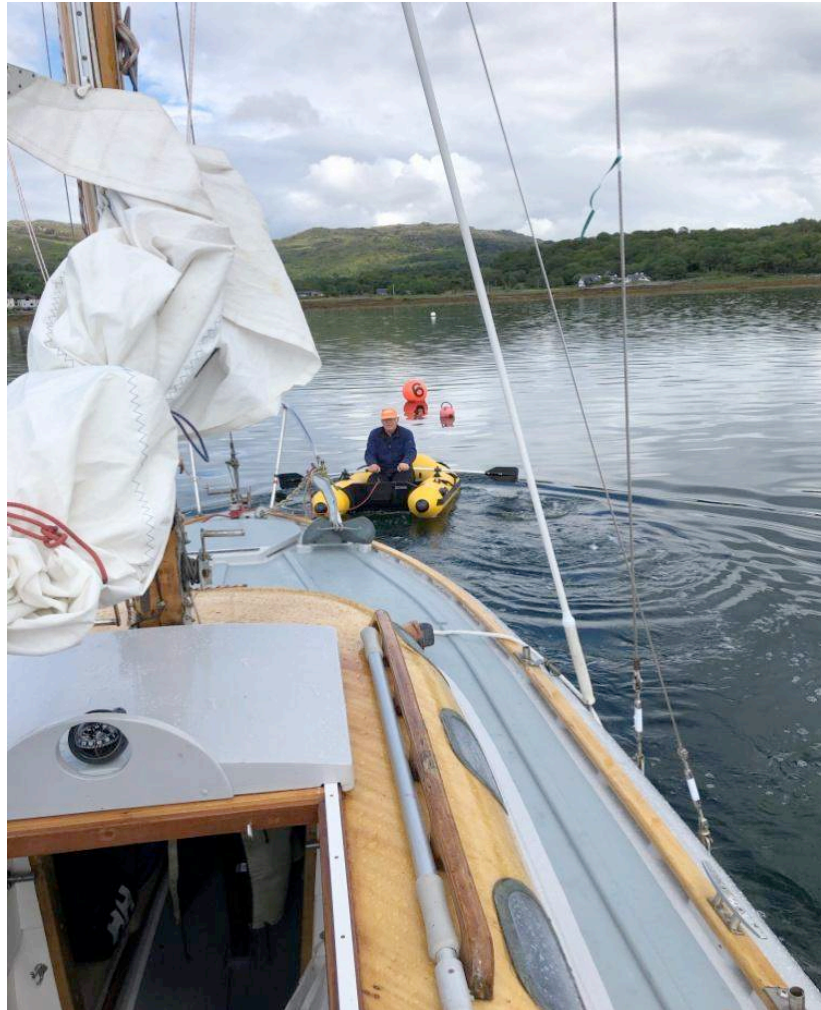
Towing at 1.2 Knots

Once safely back on my mooring I could relax a bit. The sea cock was of the gate valve type and the handle turned freely but did not open the gate. I pushed and pulled the shaft and eventually the gate must have opened enough as I could feel the body of the strainer go cold as the sea water entered. The next task was to inspect the pump, and not surprisingly, the impeller had disintegrated so a full strip down of the raw water system was needed to ensure that there were no pieces of the impeller blocking, especially the heat exchanger. It was a fine day and with a fresh mug of tea we both worked away well together. As a spare I had an old impeller that was changed as a precaution the previous season. When the engine was started there was a good flow of cooling water from the exhaust. At this stage I am sure many crews would have then set off to make the best of the rest of the forty eight hours of forecast good weather. The pages of PBO are filled with tales of crews putting to sea thinking they have rectified a defect. As Edward and I are both professional helicopter pilots we have a responsible attitude to safety and the only discussion was when and how to fit a new sea cock.

We went ashore and negotiated with the yard when we could lift out to affect a repair which was not until the following Thursday after Edward had returned to Australia. The good news was that the tide would be ideal to lift out in the morning giving me the day to do the work and lift back in the following day. On the drive home we stopped at Inverness and bought a new DZR ball valve to replace the gate valve type sea cock. I was a lot more satisfied that this would be a more reliable fitting.

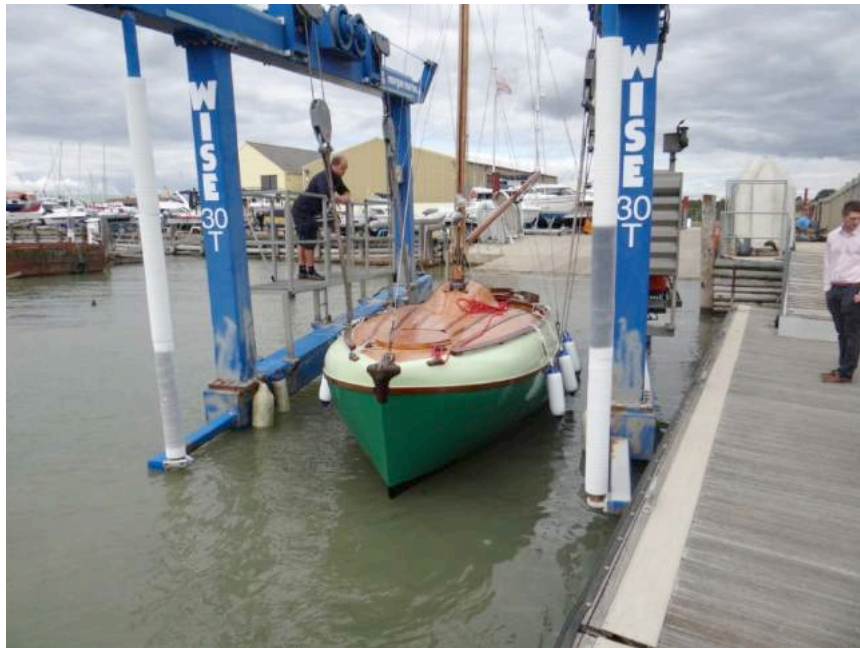
Figure 42

Anyway, ATALANTA finally got her bottom wet – and leaked. Badly enough for her to be lifted out immediately. The leaks were my fault entirely. [Fig 42]

There were six leaking (small boy sized) sites and further investigation revealed that there were eleven sets of holes without the necessary nuts and bolts.

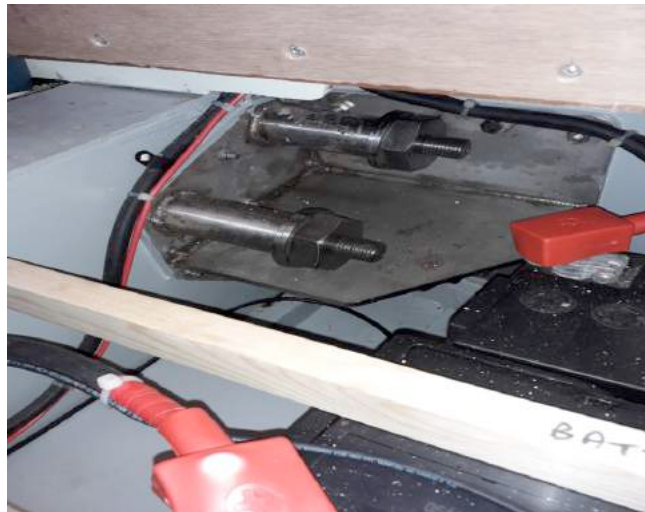
Figure 43

A year earlier I had assembled the keel boxes, keel bolt steelwork and re-installed the keels. In my haste I had neglected to install all the nuts and bolts securing the steel plate in the keel box, through the side of the keel box, to the three dimensional steel bracket on the inside.

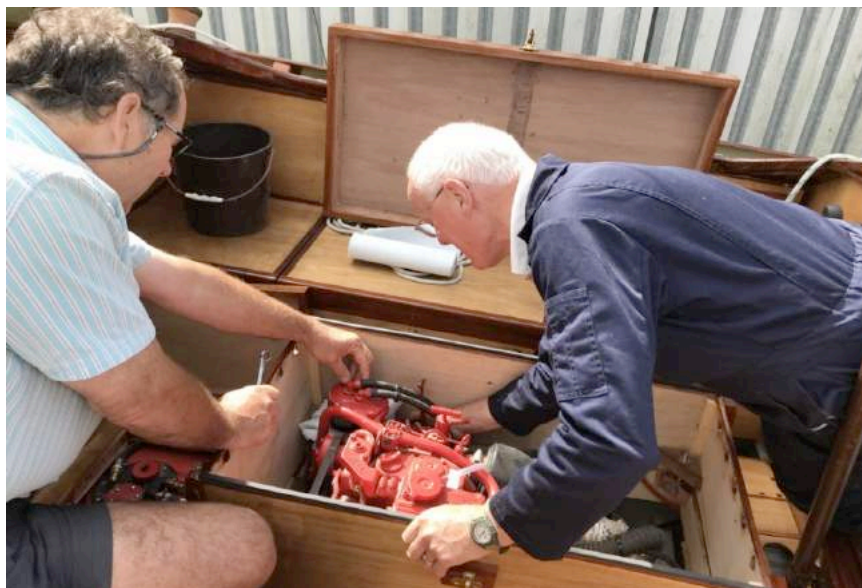
Figure 46

But another problem became apparent, fuel starvation. As the engine was brand new, and the fuel as clean as it could be, there had to be air getting into the suction side somewhere. Yes, the engine could be bled and it would run for about 15 minutes without problem. Nick and I worked out that the 15 minute period was about the same time that it took to empty the fuel filter on the engine. In other words, once the fuel filter was empty, the lift pump was sucking air from somewhere. Yes, some fuel could be persuaded to come though by over-revving the engine, but overall, it was not ideal and somewhat erratic for close-quarters manoeuvring. But we made our way from Morgan Marine to the visitor's berth on the remote pontoon without damaging either ourselves or anyone else. [Fig 46]

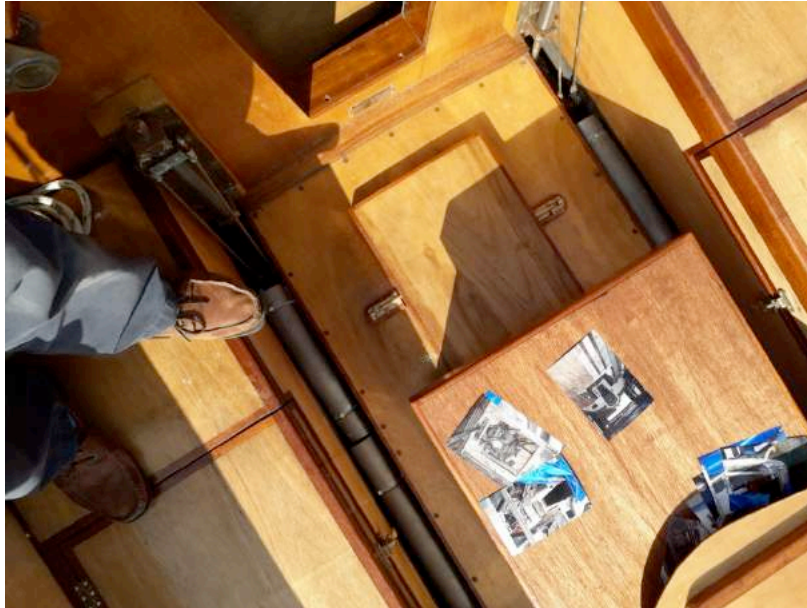
Figure 47

But the water slopping from the open-topped keel boxes was something else, and needed to be sorted before we set off round the coast. We slept on it and came up with the temporary solution of stuffing polyurethane pipe insulation down into the top of the box, largely blocking off the hole. It worked even though it didn't look too elegant. [Fig 47]

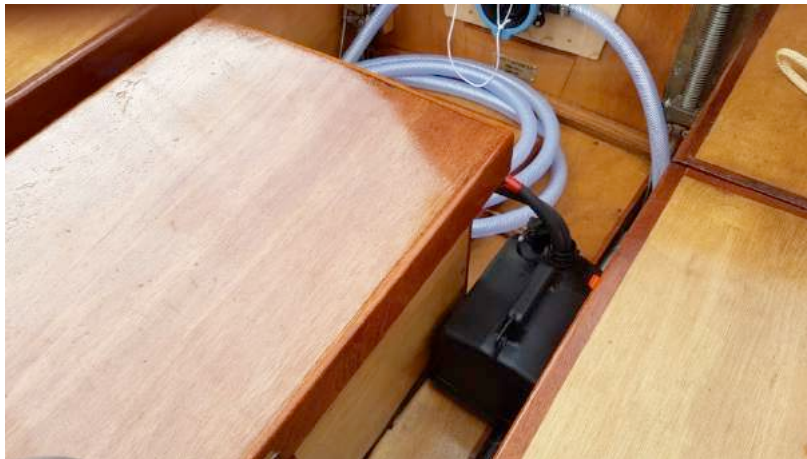
Figure 48

The fuel starvation problem continued to exercise minds. Reading the manual (always a good start!) revealed that the engine fuel lift pump was only rated for a 30 cms lift. The installation was nearer 45 cms. Could this be the problem? Nick came up with a work-around; have a temporary fuel tank on a level with the engine with the suction and return hoses stuffed into the top of the temporary tank. Et voilà – it worked, though the small tank had to be topped up as the contents were used. [Fig 48]
