Atalanta Owners' Association

*61st Annual
Bulletin*

A169 “Elle” (formerly Kerry Piper) Wooden Boom and Mast rebuild 2018 by Chris Green

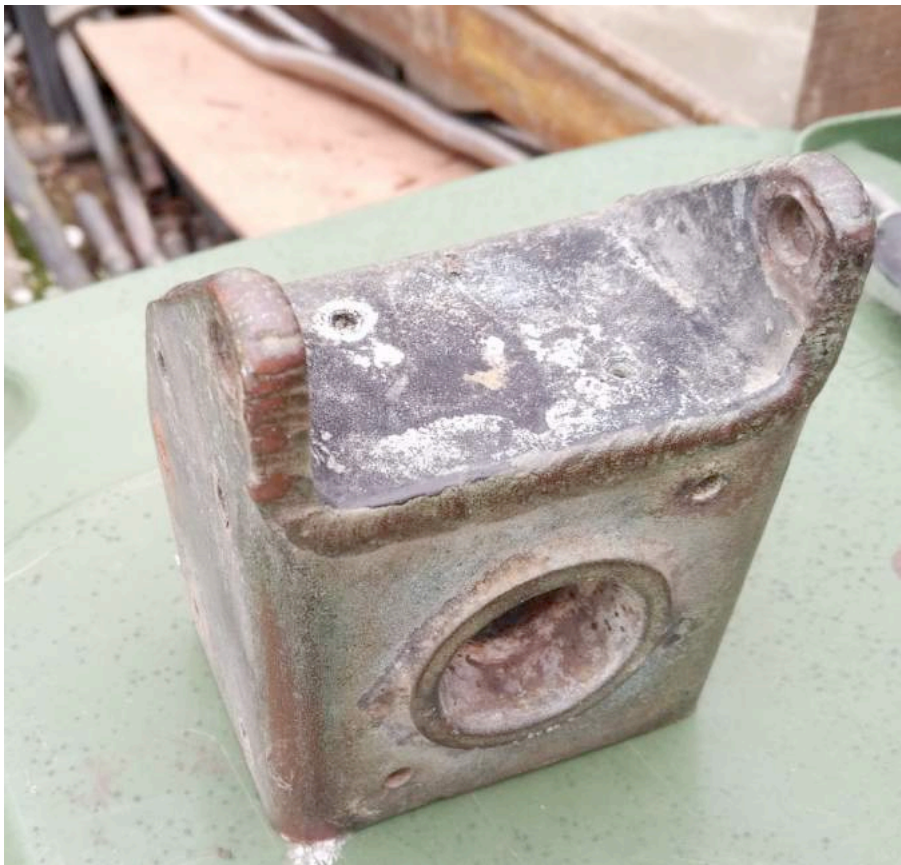
Figure 34. Mast step.

Mast base had the remains of the oxidized galvanised (halyard winch) bolt removed – see photos for the damage caused to this area, the timber was mostly sound however and was given an initial saturation coat of epoxy into the opened grain.

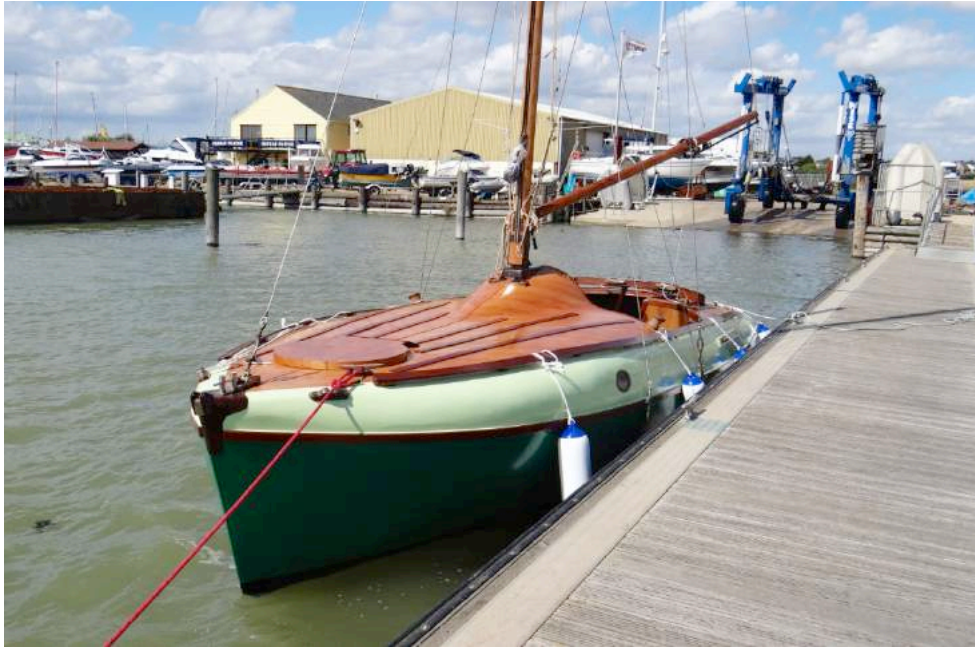
Figure 45

ATALANTA was launched a second time, thankfully without significant leaks – or so we thought. [Fig 45]

But another problem became apparent, fuel starvation. As the engine was brand new, and the fuel as clean as it could be, there had to be air getting into the suction side somewhere. Yes, the engine could be bled and it would run for about 15 minutes without problem. Nick and I worked out that the 15 minute period was about the same time that it took to empty the fuel filter on the engine. In other words, once the fuel filter was empty, the lift pump was sucking air from somewhere. Yes, some fuel could be persuaded to come though by over-revving the engine, but overall, it was not ideal and somewhat erratic for close-quarters manoeuvring. But we made our way from Morgan Marine to the visitor's berth on the remote pontoon without damaging either ourselves or anyone else. [Fig 46]
