# Atalanta Owners Association

2015—2016  
57th Annual Bulletin

**Atalanta Owners Association  
2015 – 2016 Bulletin**

**57<sup>th</sup> Edition**

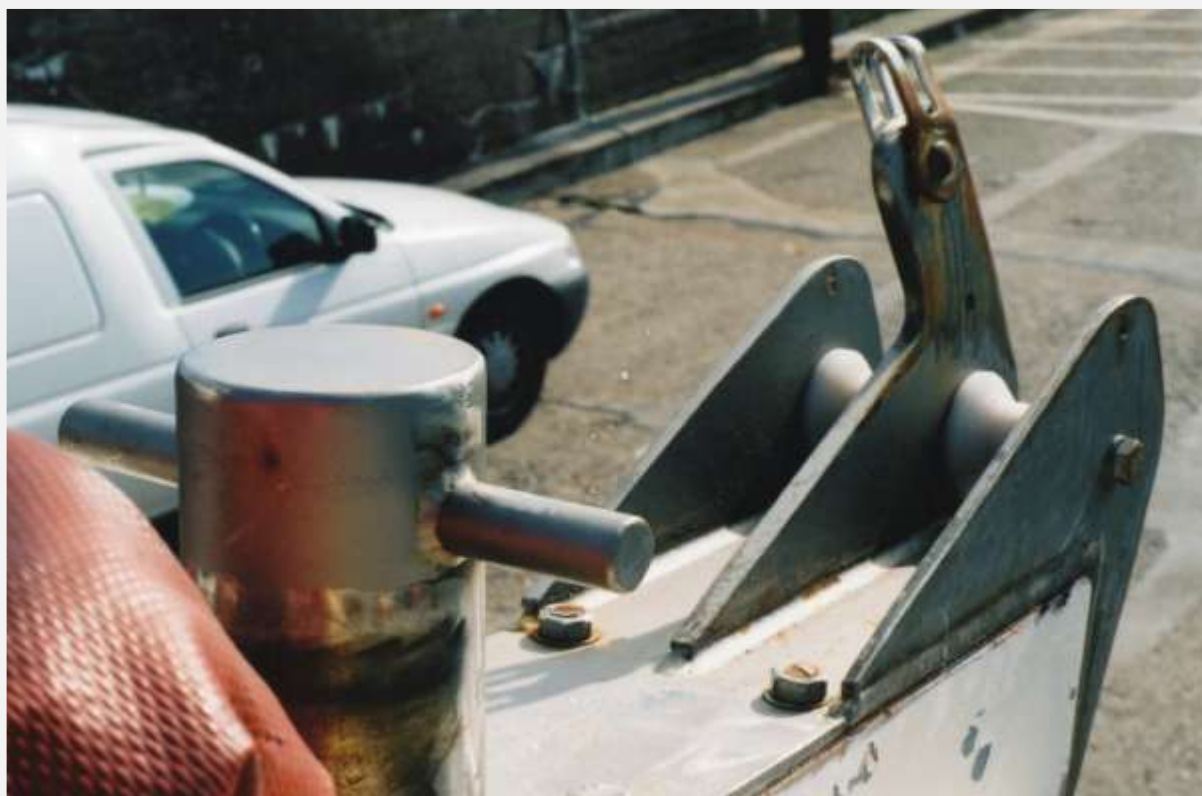
**The bow fittings and Sampson post which proved to be so strong**

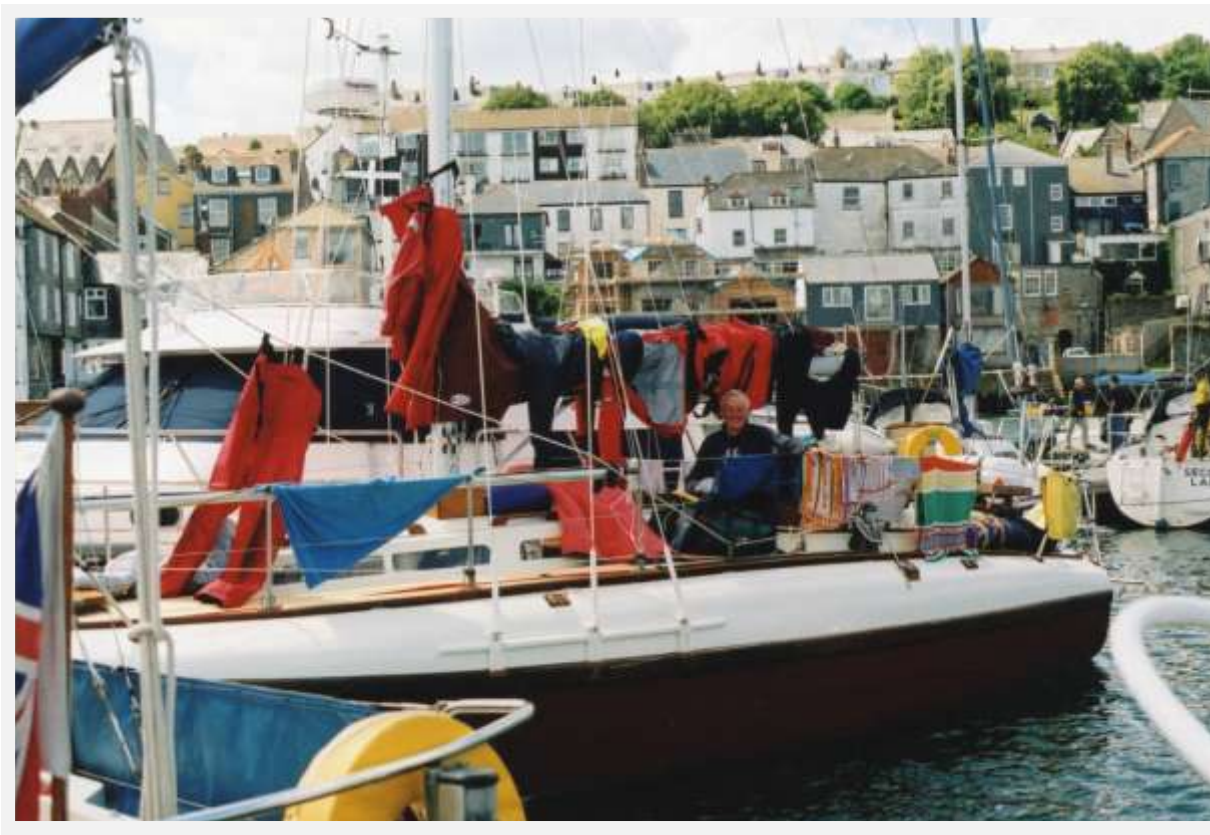
**Drying out Gellie in Falmouth**

The boat had suffered some superficial damage; loss of rudder blade, damage to the wooden deck up by the Sampson post where the wire tow line had been thrashing

To cut a long story short, I chose to take her home by road and she was loaded onto a bespoke boat transport trailer four days after arriving in Falmouth. Once back up home in Stonehaven, I carried out the necessary repairs and dried everything out. I recognised that it was going to be extremely unlikely to keep out all water should the worst happen again, but I took the opportunity to beef up the hatch coamings and enlarge all the limber holes to aid water getting to the pump suction more easily. I also fitted a non-return valve in the engine space bilge pump discharge line. And I fitted a Navtex – which meant I never missed another forecast.

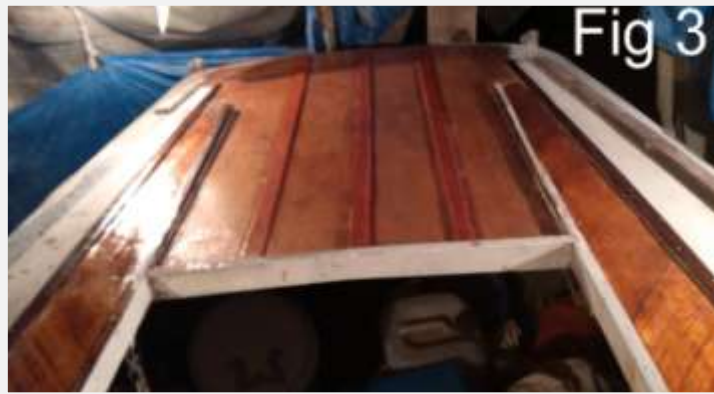
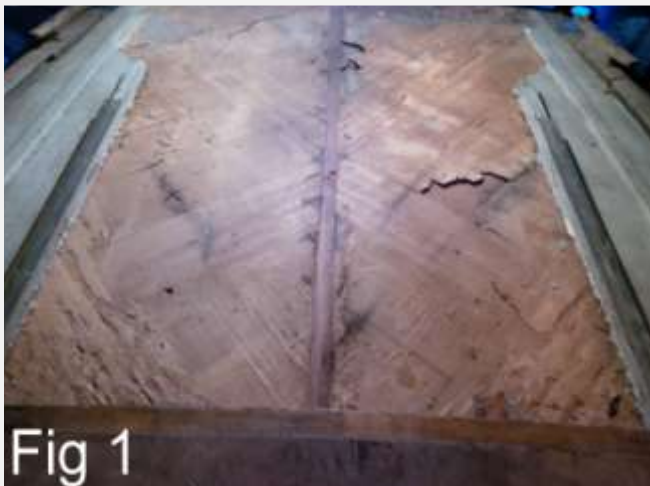
### Aft deck repair (Figs 1 – 3)

underneath. Preparation: Central section of aft deck stripped to the outer veneer; three central stringers removed; damaged veneers (see photos) repaired with agba patches/epoxy glued. With ambient temperature around zero heating the aft cabin below warmed the deck to assist curing. After sanding, the repaired section was coated with a thickened mix of West 405 filleting compound onto which two sections of 4mm gagoon structural marine ply (\*see note below) was fixed. The pre cut sheets were laid full length with a join at the centre. Weighting the new deck from above and wedging shoring props below provided compression while the epoxy cured. Replacement hardwood stringers were then glued into place - the centre join covered by the middle stringer.

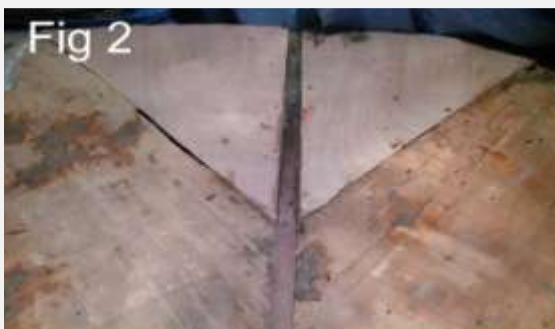
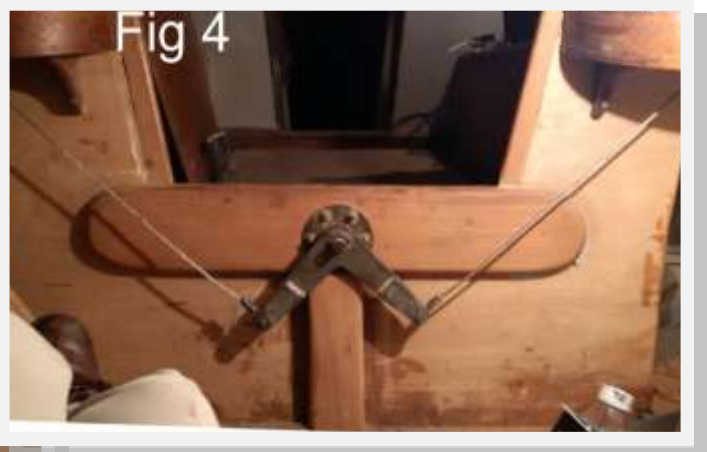
The hard top-coating had split and/or detached from the agba substrate in several places allowing water ingress/delamination

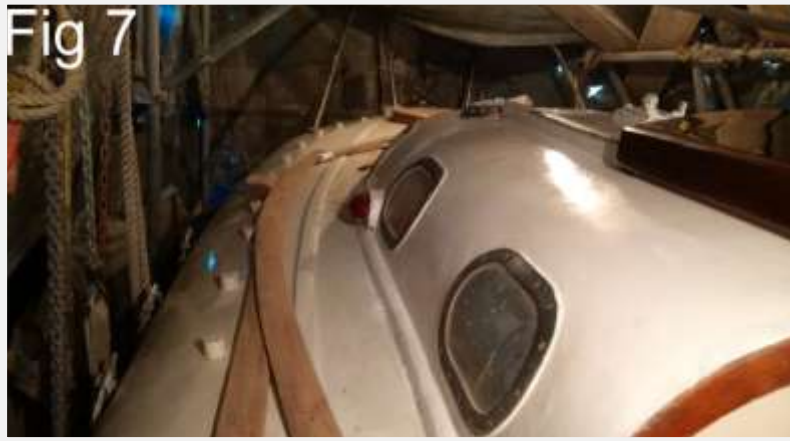
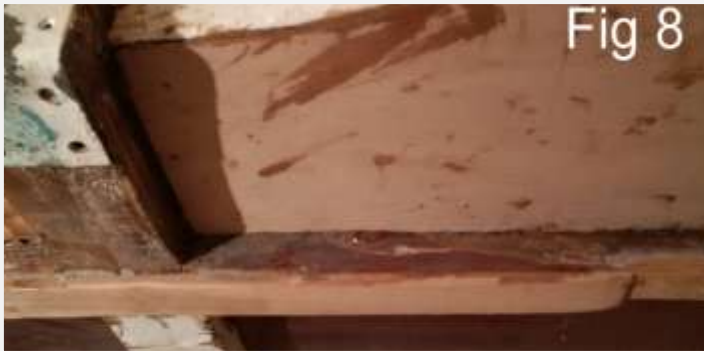
**Exterior repairs)  
Side and foredeck (Fig 7 -9)**

Inboard of the shroud chain plates stress cracks in the deck coating resulted in water ingress and delamination of the side decks, consequently veneer had *sprung* adjacent to the starboard forward chain plate. Wet rot was removed from a 50cm square section of the foredeck area between the coachroof and hatch. Either

side of the bitts had minor rot above the strake. Repairs were straightforward - rot replaced with agba laminate glued with 106 grade epoxy and West 405 filleting mix.

(NB: Fairey drawing B 12388 covers laminate repairs). The deck to coachroof join (foredeck replaced) was bonded with Trimol 3 part epoxy grout *see above*. Scaffolding screw jacks between keelson and coachroof (under join/frame) maintained position while the Trimol cured.

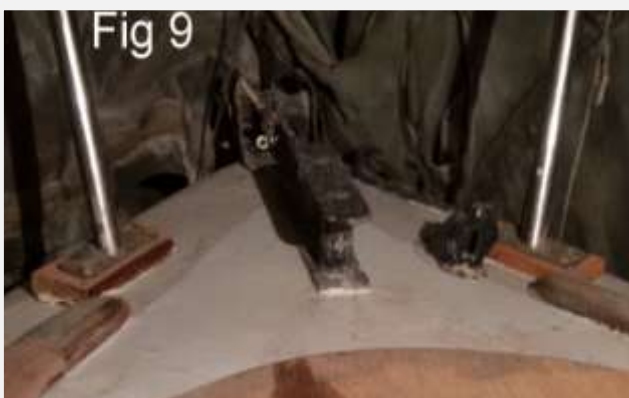
The port galley area where a section of strake, topsides and deck had been replaced, required new deck fittings: stringer (part); stanchion support base and cockpit sheet winch bases etc (fig 9). Toe rails and support pegs had been removed earlier; most rails were reusable after sanding and varnishing, so only one short (blister) section had to be made up from scratch. Two damaged rails were cut back and scarfed with epoxy glue to form a sound single rail (clamp and splint join fig 8). Several replacement cleats were made up from scrap teak as originals had deteriorated to wood crumble.

cut back and scarfed with epoxy glue to form a sound single rail (clamp and splint join fig 8). Several replacement cleats were made up from scrap teak as originals had deteriorated to wood crumble.

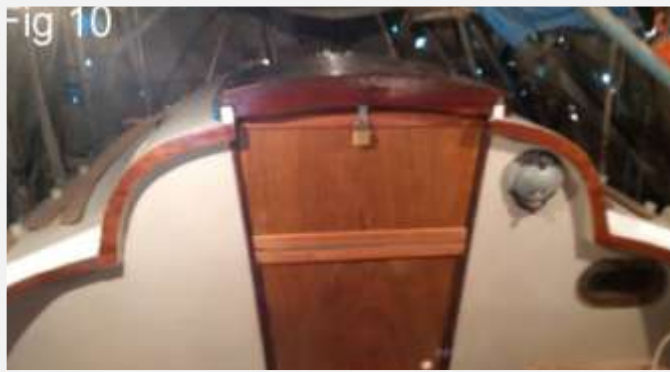
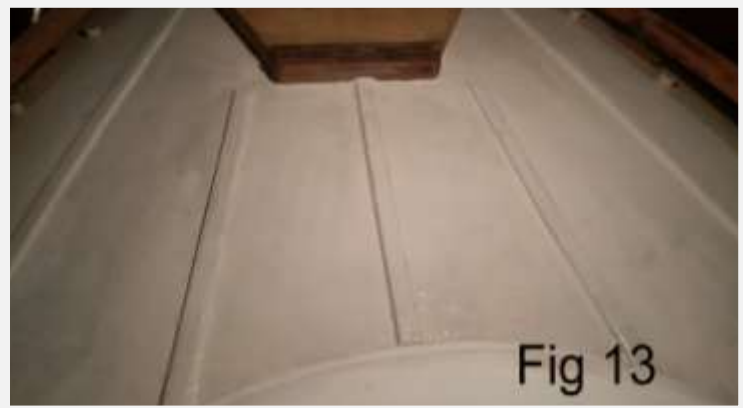
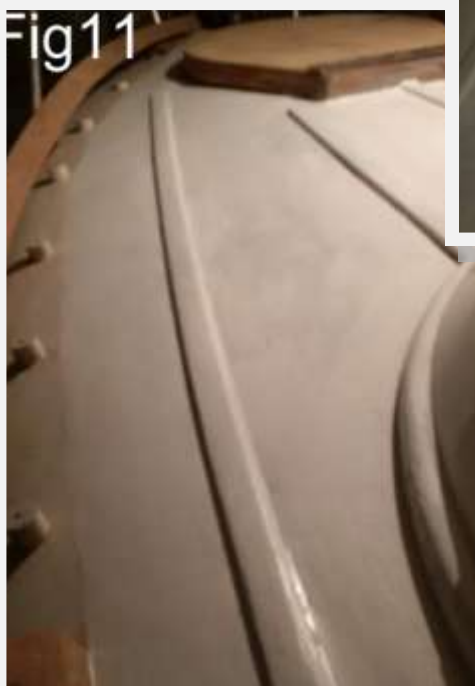
#### Exterior finishing: (Fig 10-13)

Hull painting / deck fittings – *learning curves* – *artex epoxy*  
 Replaced sections of topsides, deck and strake (previous article) required consid-

erable fairing and rubbing down to achieve an acceptable finish. To my eye, looking forward from the cockpit, there was a faceted edge in replaced topsides curved sections above the strake towards the bow. I decided early on to sand the strake back and var-

nish it; this was a major job as this had been painted for the last 20 years+, Removing the paint was worthwhile though, as degradation to the upper hull join was revealed in several areas.

A thin clear epoxy primer coat was applied over prepared areas, prior to final sanding. Strake, toe rails etc were finished with UV varnish coat.

All varnished (and painted) areas were given an epoxy coat prior to UV resistant varnish for added protection. After the toil to eliminate rot in various forms, protection

remained paramount. NB: I learned from experience to keep epoxy priming coats thin and even. Early high gusto roller applications of epoxy had dried with a ripple effect, not quite artex, but far from the intended glass sheet.

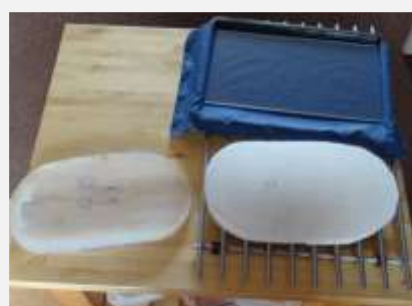
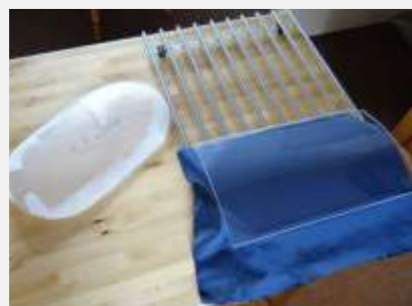
### Bending blanks

- **Cut rectangular blanks** just larger than the size
- **Heat using manufacturer’s guidance** on temperature and time. I placed the blanks on a baking tray in our domestic fan oven and after a trial found, for my acrylic, 7 minutes at 165° Celsius was about right. (I didn’t use a thermometer but did two ‘trials’ before moulding the actual windows)

- **Mould the windows.** I used a fine silk cloth on the baking tray under the acrylic which I used to transfer it to the mould. I found very little pressure was required and the acrylic formed easily just under gravity helped by a gentle push using the old window and another piece of cloth.

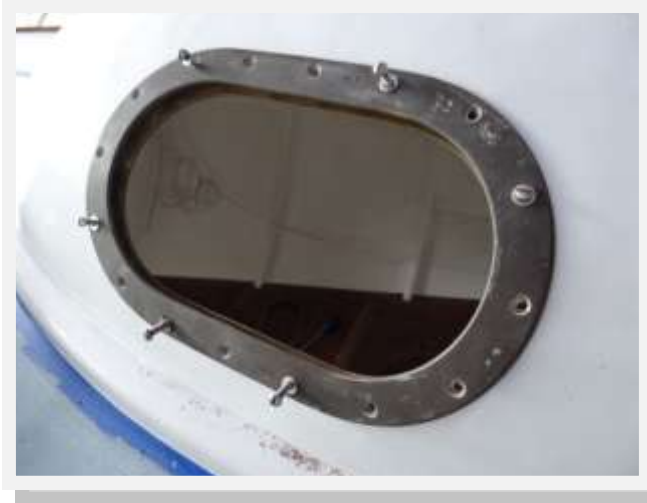
the bronze frames, easily bending around the curves by compressing the inside edge (rather than extending the outer edge).

Tape thickness should be chosen based on the thickness of the blister and acrylic used. The tape must be compressed by at least 30% to be watertight. My blister was between 8mm and 9mm thick and I used 4mm acrylic. I chose 3mm tape outside and 6mm tape inside to position the Perspex towards the outside of the gap.

Before the tape is compressed the short bolts used in the frames did not reach between the frames. I temporarily replaced every other bolt with a longer (25mm) version that could be used to compress the tape and allow fitting of the shorter bolts.

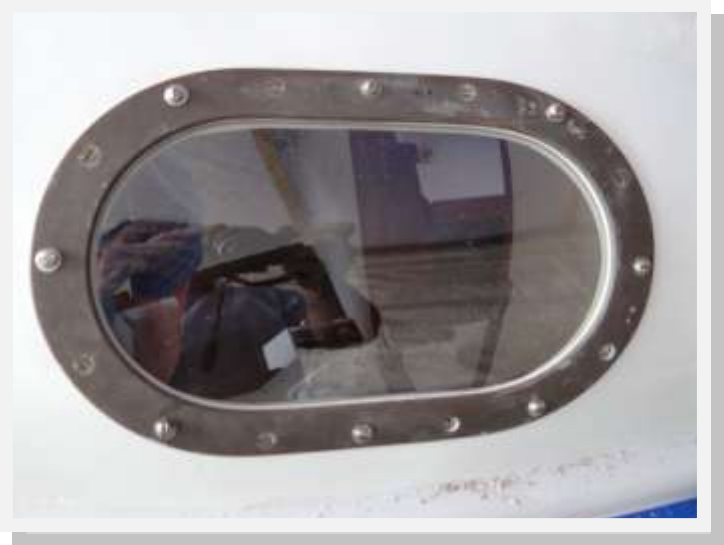
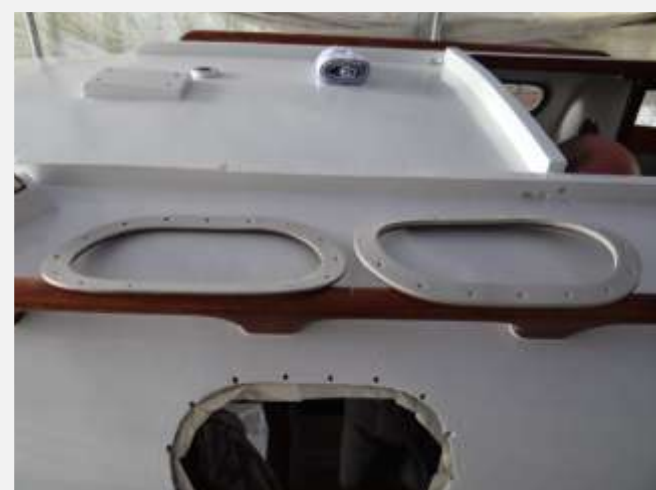
I also lightly marked the position of the frame on the blister with all bolts tight to assist later assembly – see above.

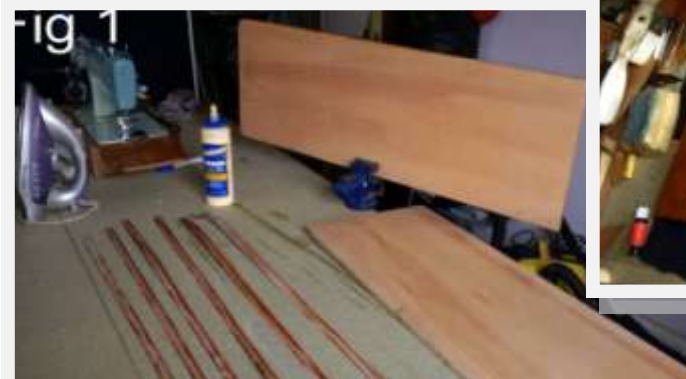
**Making a table top for KP**

veneer. See photos for the KP table top creation; and the schematic for technical, component and fittings detail. At the time of writing I am still refurbishing the interior so have no pictures of the new table in

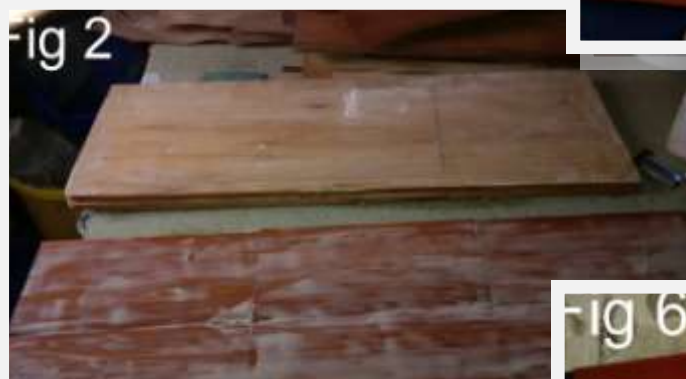
**Fig 1** Cut 2 x 12mm plywood leaf 30cm x 85 cm (each); radius 2 corners (inboard

after); apply edge hardwood veneer strips with iron and waterproof grade veneer glue applied to both surfaces;

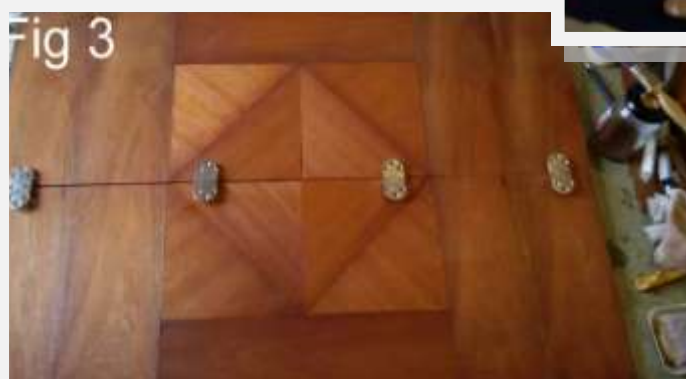
**Fig 2** Apply glue to both veneer and plywood leaf and allow to touch dry for

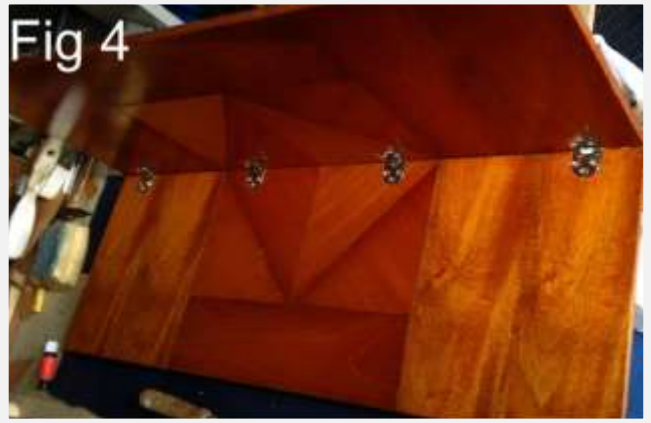
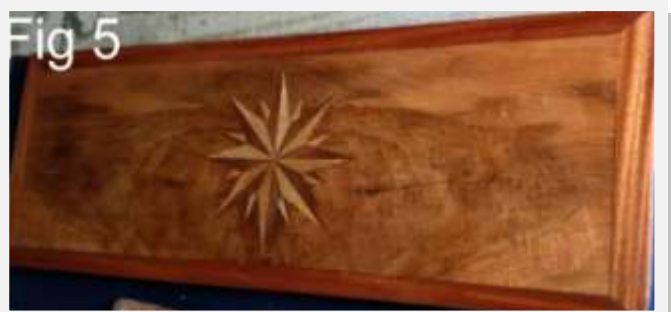
application – here the underside ((base) panel veneer is ready; application by hot iron.

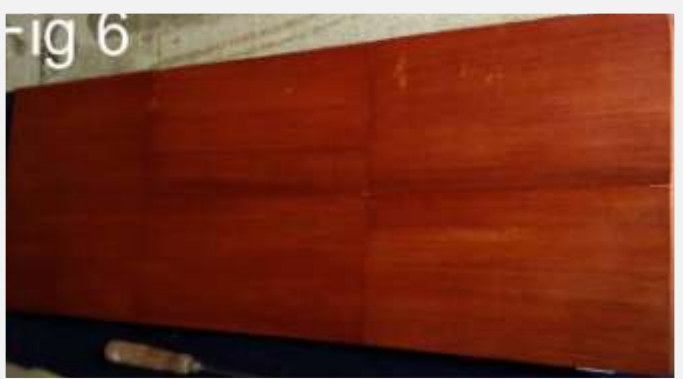
**Fig 3** Self-supporting hinges in place for marking.

**Fig 4** Hinges fitted;

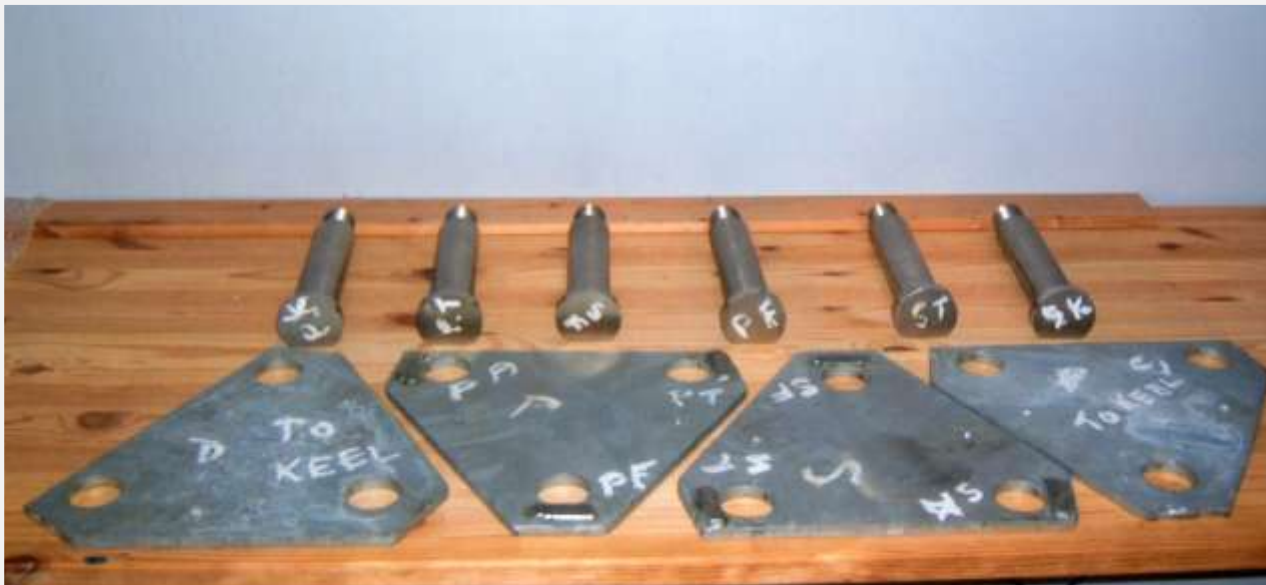
**New keel bolts and pressure plates**

nie, one of the old school and even older than I am, turned up six new stainless steel bolts to the club's drawings and made new clamping plates.

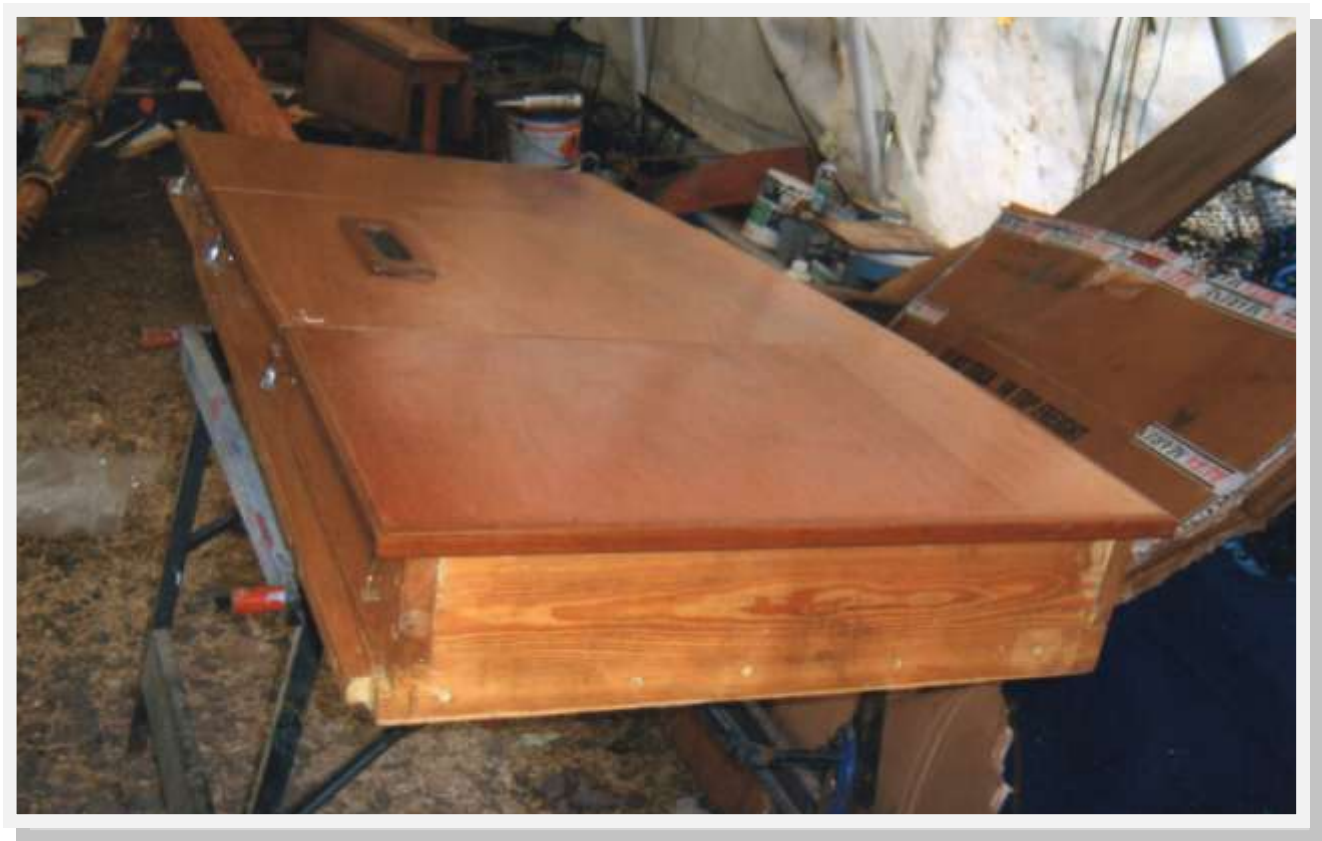
### **New engine hatches and cockpit floors to the original design**

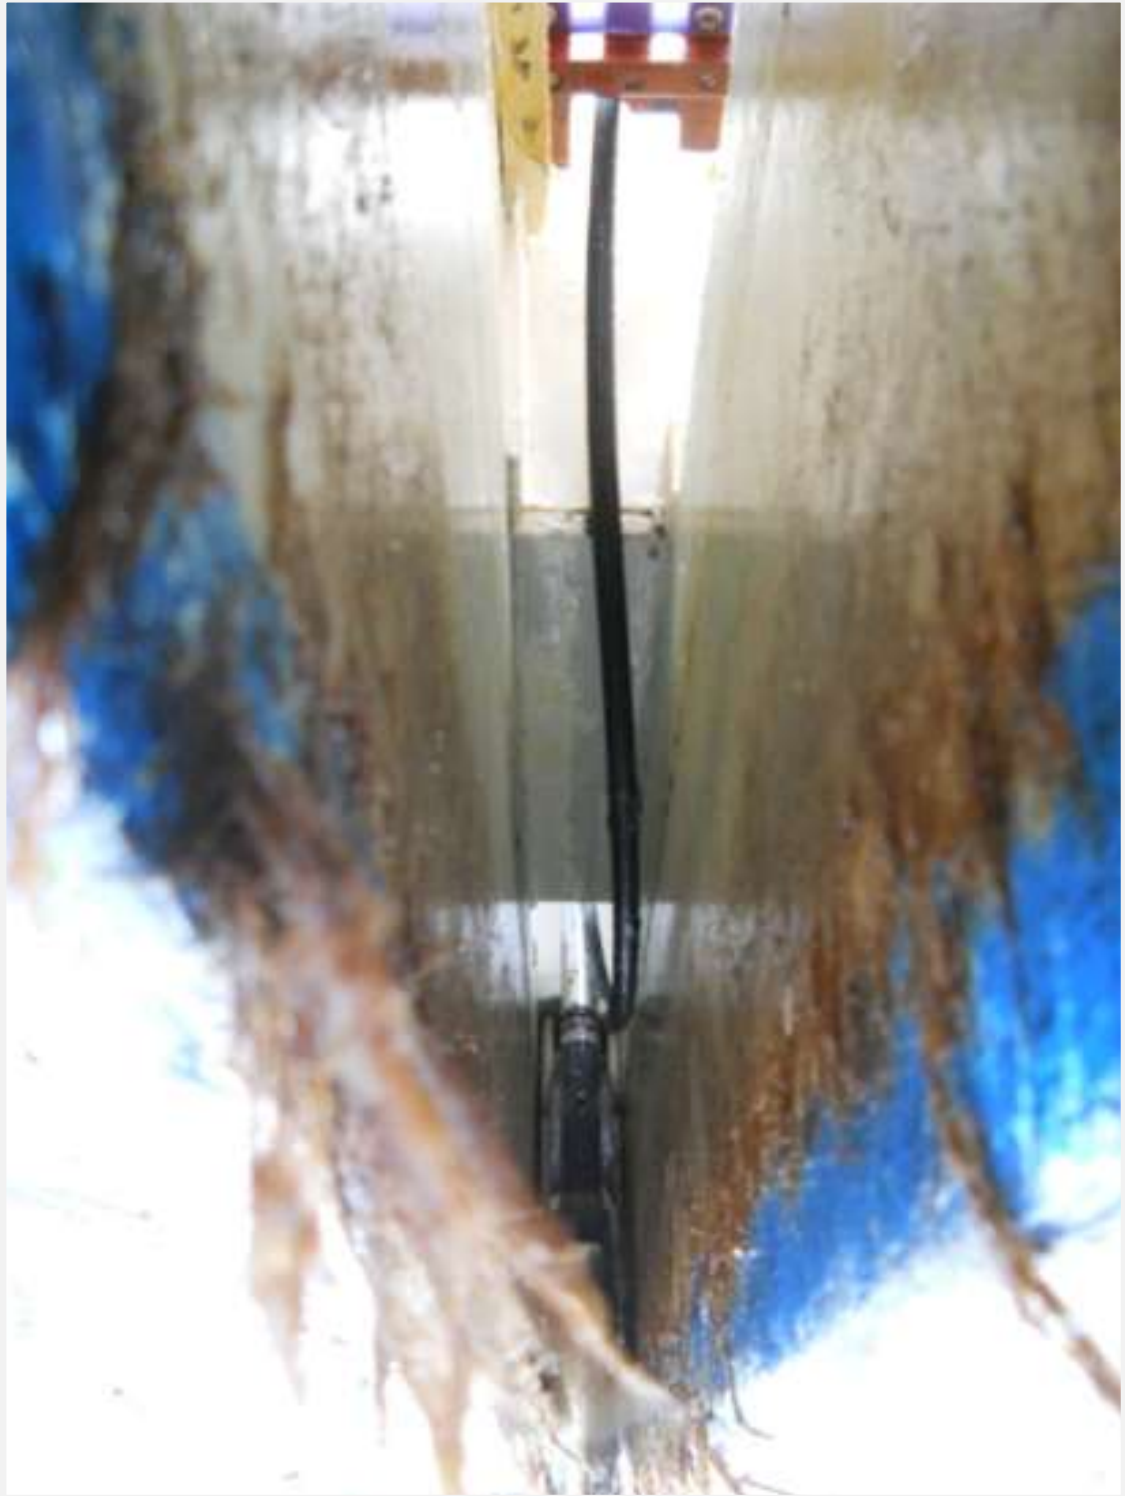
### **The hydraulic keel lifting mechanism inside the keel boxes**
